ANNUAL REPORT FOR 2010

Phipps Creek Site #11 Mitigation Site
Yancey County
TIP No. R-2518B

Prepared By:
Natural Environment Unit & Roadside Environmental Unit
North Carolina Department of Transportation
December 2010

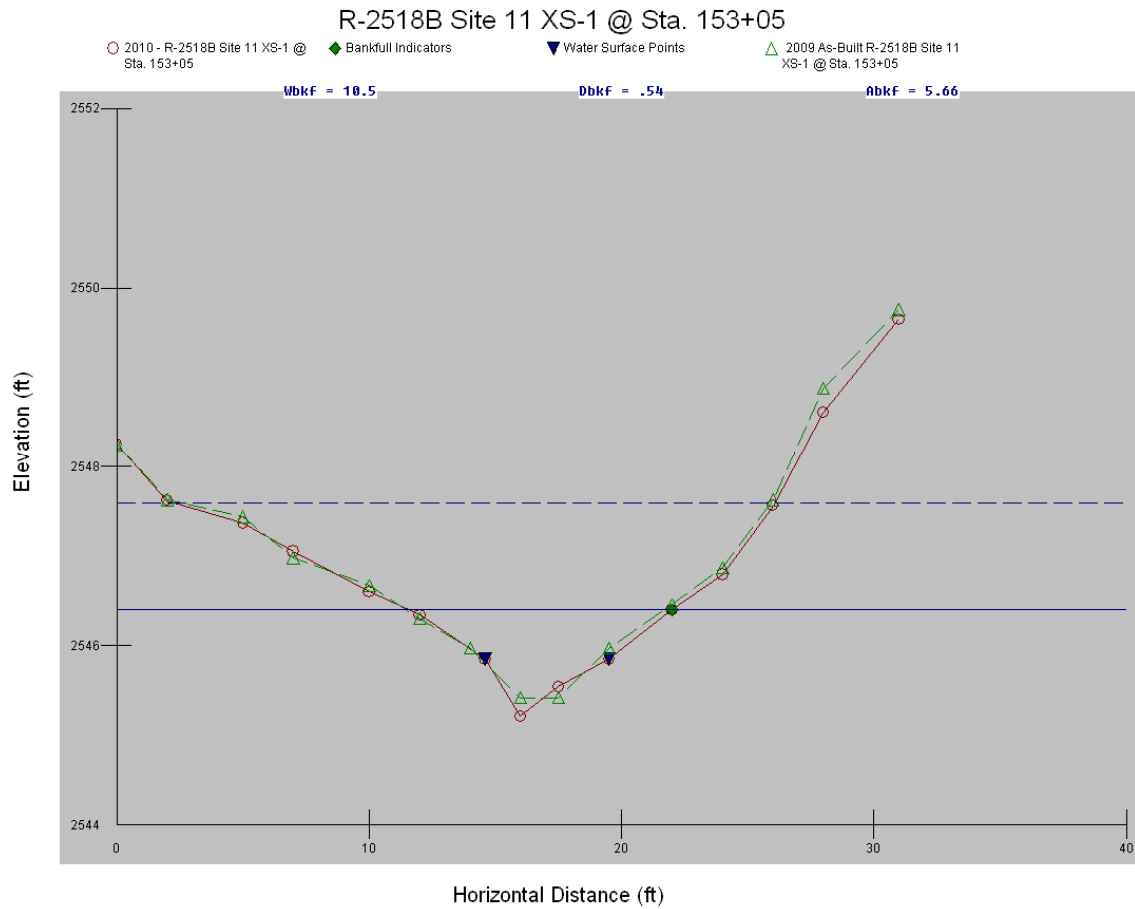
Based on comparisons of the As-Built to Year 1 monitoring data, all of the cross sections appear stable with little or no active bank erosion. Graphs of the cross sections are presented in Appendix A. Future survey data will vary depending on actual location of rod placement and alignment; however, this information should remain similar in appearance. The longitudinal profile showed that the channel was stable for the 2010 monitoring evaluation. Pebble counts were not required per the permit conditions and therefore were not completed.

Site #11: Cross-Section #1 (Riffle) Abbreviated Morphological Summary					
	2010	2011	2012	2013	2014
Bankfull Cross Sectional Area (ft ²)	5.66				
Maximum Bankfull Depth (ft)	1.19				
Width of the Floodprone Area (ft)	23.7				
Bankfull Mean Depth (ft)	0.54				
Width/Depth Ratio	19.37				
Entrenchment Ratio	2.27				
Bankfull Width (ft)	10.46

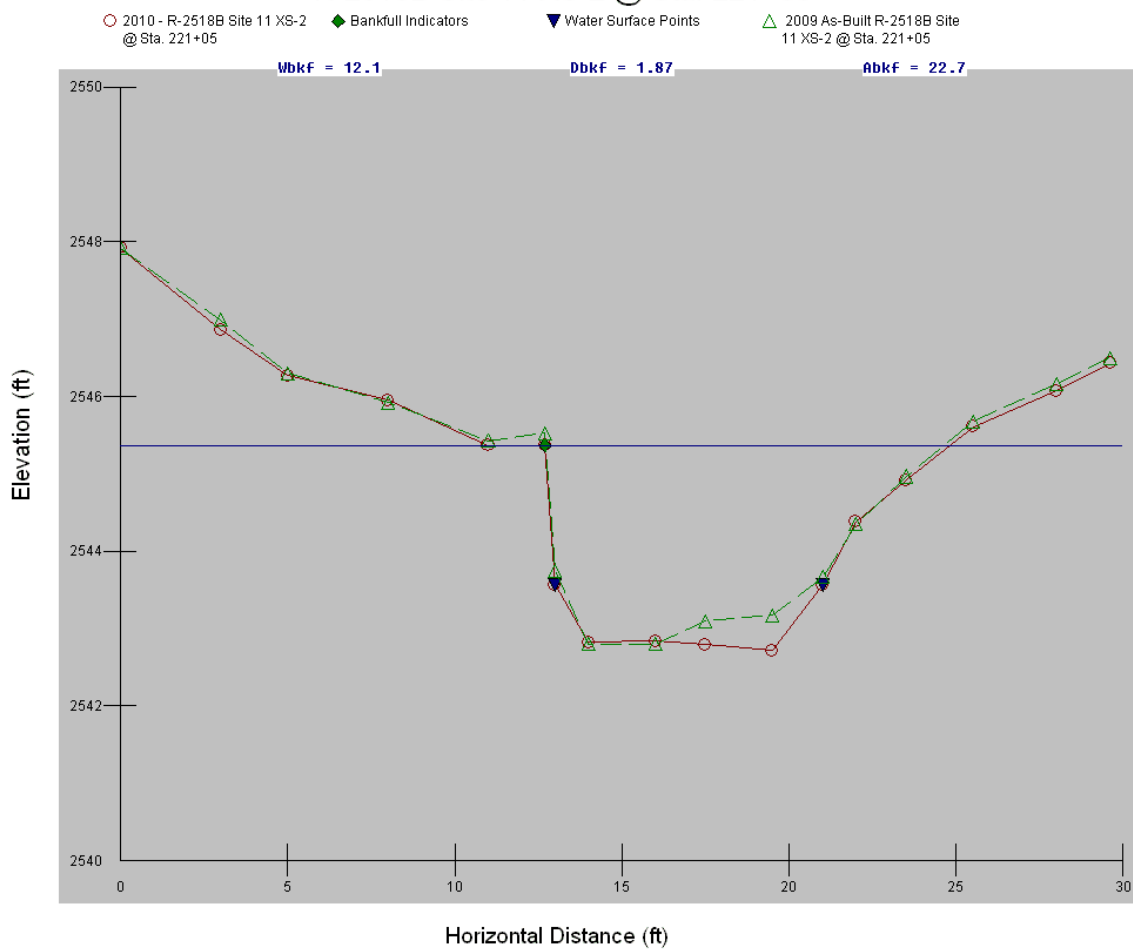
R-2518B Site 11 XS-2 @ Sta. 221+05

Site #11: Cross-Section #2 (Pool) Abbreviated Morphological Summary*					
	2010	2011	2012	2013	2014
Bankfull Cross Sectional Area (ft ²)	22.69				
Maximum Bankfull Depth (ft)	2.65				
Bankfull Mean Depth (ft)	1.87				
Bankfull Width (ft)	12.1
